## Case Study - Longannet Jetty Inspection

**Project:** Longannet Power Station, Marine Jetty Inspection & Structural Assessment

**Client:** Scottish Power

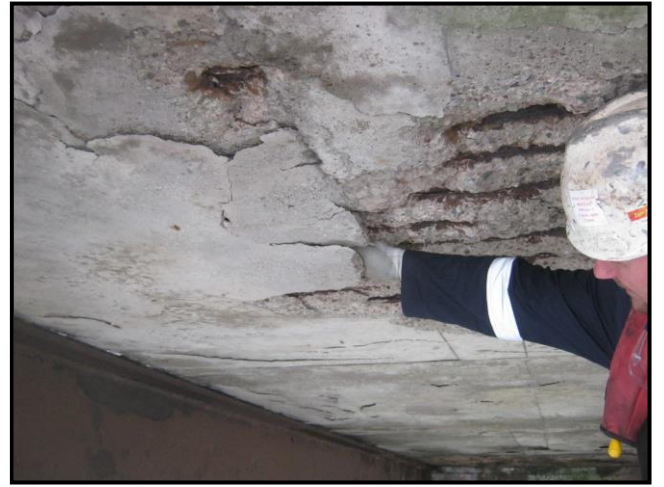
Spalling Soffit Concrete

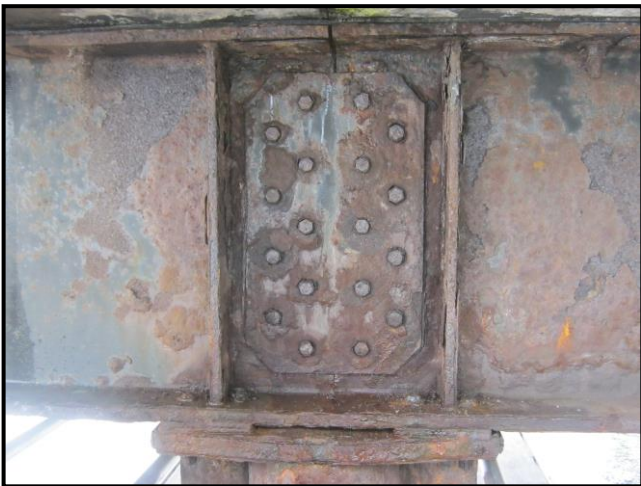
Corroded Steelwork

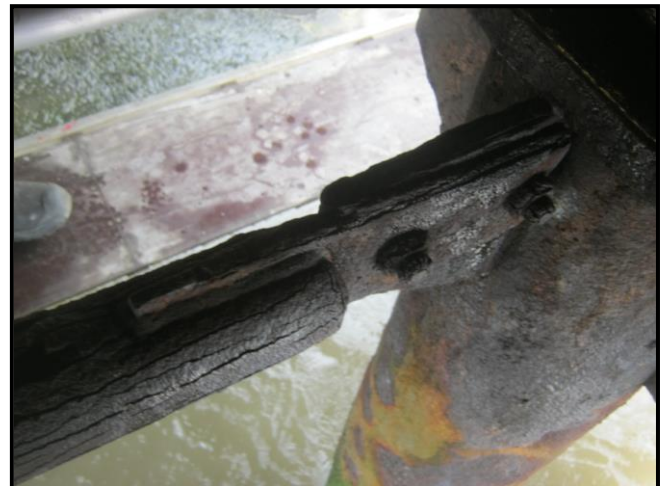
Corroded Steelwork

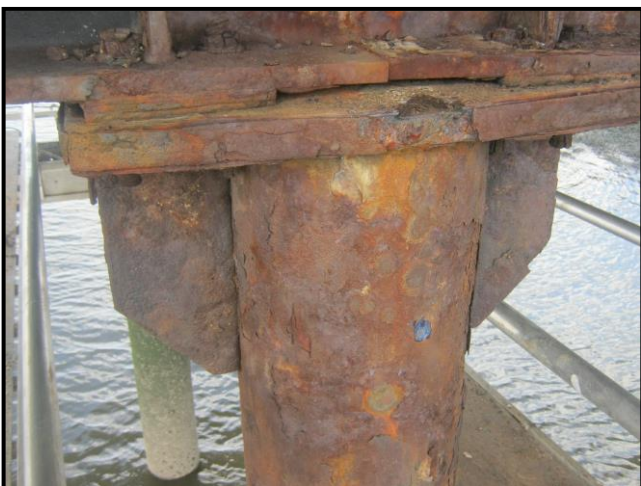
Corroded Steelwork
